RESEARCH

FULL-SCALE THREE-STOREY HOUSE BURNED IN JAPANESE TEST

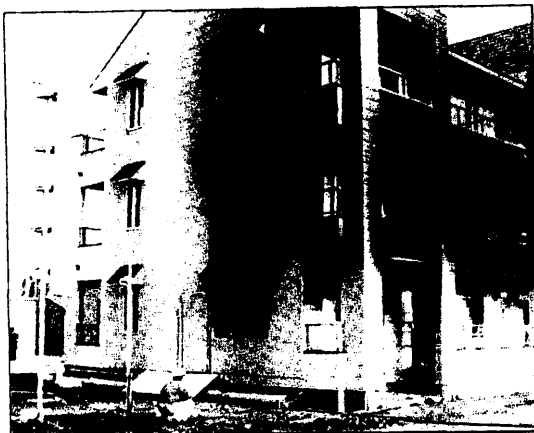
FIGURE 1: View of test house at end of 60 min fire test. Note the unbroken windows of the upper storeys, indicating the effectiveness of balconies and 'eyebrows' in preventing the fire from spreading into the apartment above.

The fire test involved about 35 kg/m² of fuel load being distributed throughout the three full apartments. In the first floor apartment of fire origin, mostly realistic furnishings were used, with wood cribs being substituted in the upper two apartments. Within the room of origin, the fire developed rapidly and, interestingly, averaged near the ISO 834 temperature/time curve for the 1 h period. The success of the experiment lay in the fact that at no time during the 1 h test did the fire spread beyond the apartment of origin; in fact, the fire, while thoroughly burning out the front two rooms, did not even involve the back bedroom (see Figure 1).

One factor contributing to the good performance of the test structure was the fact that balconies or 'eyebrows' were used throughout, protecting upper-storey windows from flames coming from windows below. This architectural feature is very common in Japan, but is somewhat uncommon in Western building practice.
